IAC-17.A6.3.6x41656

CHARACTERIZING DEBRISAT FRAGMENTS: SO MANY FRAGMENTS, SO MUCH DATA, AND SO LITTLE TIME

B. Shiotani, M. Rivero, M. Carrasquilla, S. Allen¹

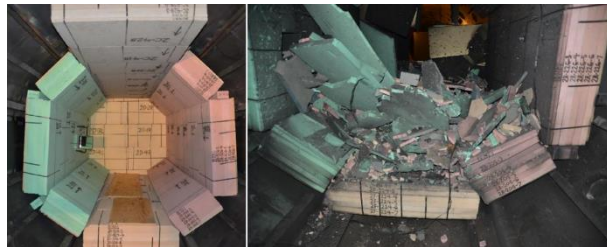
Figure 2 Panel layout inside chamber (left) and the aftermath (right)

A total of 588 foam panels were installed inside the test chamber during DebrisSat's laboratory HVI test. Three different density panels, denoted low, medium, and high, were stacked and utilized to capture debris fragments inside the chamber. The foam panels were arranged such that the density of the panels increased radially out towards the wall of the test chamber.

extract fragments from medium and high density panels are less than 6 hours, however, the times for low density panels is approximately 22 hours. Since the panels were arranged in the test chamber such that the panel density increased radially outward, during the impact test majority the fragments impacted the low density panels and only the more energetic fragments reached the higher density panels (shown in Figure 2).

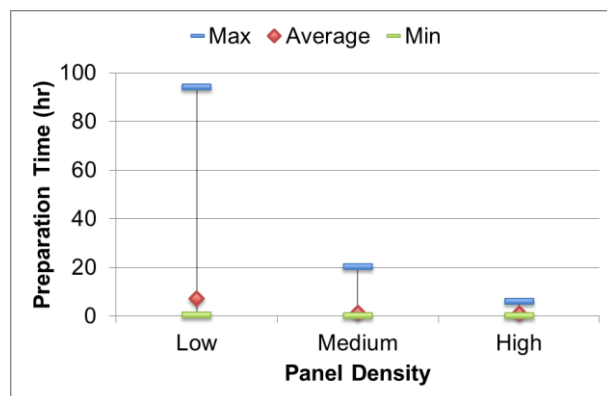
Figure 3 Full foam panel preparation times

The preparation times for each panel density category are shown in Figure 3 and Table 5, specifically, the average, maximum, and minimum times required to prepare the panels are shown. The preparation times for the low density panels are significantly greater than the preparation times for medium and high density panels, since most of the fragments were captured by the low density panels.

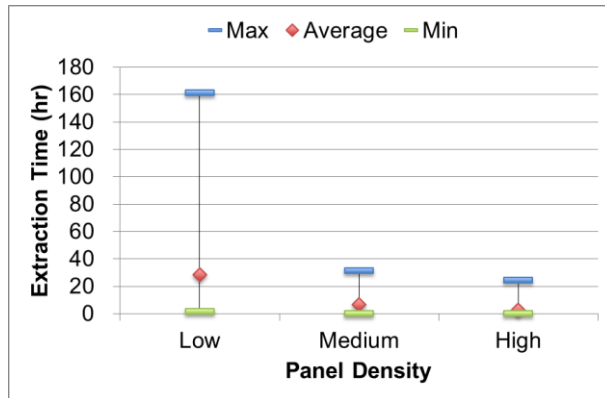
Figure 4 Foam panel extraction times

Currently, a total of 285 full panels have completed extraction, out of which 79 panels are low density, 135 panels are medium density, and 71 panels are high density. The average, maximum, and minimum extraction times for each panel density are shown in Figure 4 and Table 6. Similar to the preparation times, the low density panels require more time for extraction on average due to the higher fragment counts captured in them. There was a low density panel that took over 160 hours to complete extraction and over 3,500 fragments were collected from that panel. For some high density and medium density panels, there were no embedded fragments identified through the X-ray images, therefore,

the surfaces of the panels were carefully inspected to ensure that no fragments are captured in the panels. It should be noted that, the extraction task involves two to four technicians per panel.

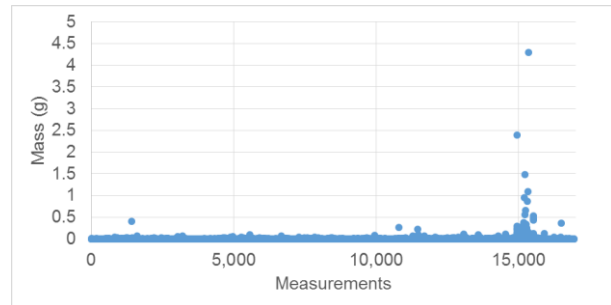
Figure 5 DebrisSat fragment mass measurements as of August 2017

As the fragment mass measurements continued, it was determined that another microbalance was needed to increase the productivity. As a result, a second microbalance was acquired and incorporated to measure the fragment masses. Similar to the first microbalance, the second microbalance is placed under a draft shroud on a separate granite table. To date, approximately 17,000 fragments have been massed on one of the two microbalances (see Figure 5). The breakdown of the fragments that were massed on each microbalance are shown in Table 8, where the first and second microbalances are denoted as Micro 1 and Micro 2, respectively. As seen in Figure 5, the majority of the fragments that have been massed so far have very small mass. Table 9 shows that the average mass of the fragments massed to date is less than 250 milligrams. As the characterization continues, bigger fragments will be massed and the maximum and average mass measurements will change significantly from what is shown in Table 9.

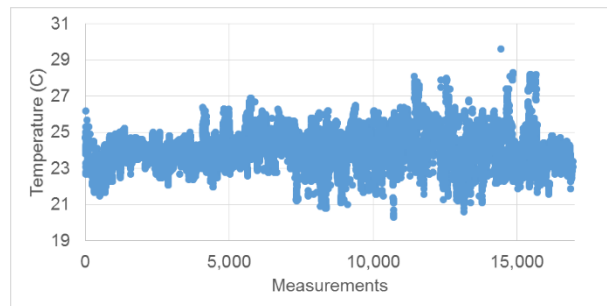
Figure 6 Temperature measurements at each mass measurement

Due to the sensitivity of the microbalance to environmental effects, the temperature and the humidity at the time of each mass measurement is also recorded and archived. A temperature and humidity sensor was placed within 2 m of each microbalance so that the temperature and humidity are also measured at the time of each mass measurement. The temperature and humidity measurements from the approximately 17,000 mass measurements are shown in Figure 6 and Figure 7,

respectively and a summary of that data are shown in Table 10. Both the temperature and humidity measurements are well within the acceptable working conditions of the balances. As the characterization efforts continue, larger fragments will be massed and will have their masses measured with the other two balances.

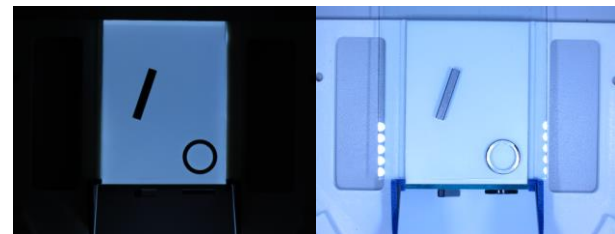
Figure 8 Back lit and front lit images from updated 2D imaging system with mirror

The initial configuration of the 2D imaging system assumed negligible height (i.e., $Z_{DIM}=0$ since the CFRP fragments have negligible height) and only the

fragment's two largest orthogonal in-plane dimensions (denoted as X_{DIM} and Y_{DIM}) were measured. However, as the characterization activities progressed and non-CFRP fragments were characterized, a right angle wedge mirror was incorporated to capture the height of the fragment. The in-plane dimensions X_{DIM} and Y_{DIM} are measured by processing the back light image (i.e., silhouette) and the height, Z_{DIM} , is obtained from the front lit image (see Figure 8).

There are two 2D imaging systems that have been developed and implemented to increase the productivity during fragment characterization process. To ensure that the characteristic length error requirement was being satisfied with the inclusion of the mirror to measure the third longest dimension, Z_{DIM} , two hollow disks were used to examine the characteristic length accuracies of both 2D imagers. The hollow disks have the same outer diameter and inner diameter and their only difference is the heights, 0.25 mm and 0.13 mm, respectively. Ten measurements were taken for each hollow disk and on each imager. The characteristic length (L_C) error was calculated by comparing the 2D imaging system measurements to the actual dimensions of the hollow disks. The hollow disk dimensions were physically measured using micrometers and their characteristic lengths were calculated. Table 11 shows the L_C accuracies of both hollow disks on the two 2D imaging systems with the mirror and without the mirror. The L_C accuracies are well within the $\pm 10\%$ requirement with and without the mirror, but the accuracies improve with the addition of the mirror. Therefore, all pre-mirror size measurements are acceptable and do not need to be repeated. Designations have been added to the database to identify pre- and post-mirror size characterized fragments.

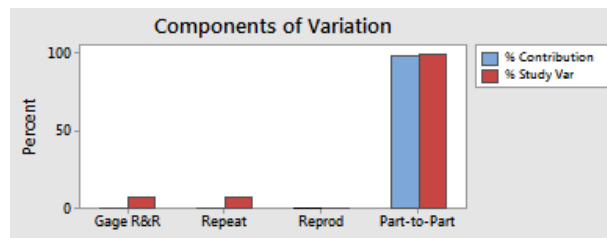
Figure 10 Test 1: Components of variation mass measurements

The first Gage R&R test took place over a period of two days due to ensuring the process was correct. All of the mass measurements were taken during the first day and the results are shown in Table 16, Figures 9 and 10. Table 16 and Figure 10 shows the variations that were calculated based on the mass measurements and Figure 10 shows the variations between technicians (including

the data from DCS denoted as Technician 4) for each fragment. The total Gage R&R was 7.3%, which is in the acceptable range for the test criteria. The variations are coming from the equipment rather than the technicians and the procedure. The part-to-part variation examines the differences between the test articles and a high variation suggests that each gage is able to distinguish each part that is tested is different. Figure 11 shows that the variations in mass measurements of each fragment by the technicians are very low and that the mass measurement processes are very good.
